FLIGHT DECK REFUELLING HOSE FAILURE HMCS PRESERVER

Technical Memorandum

DREA TM 2000-022

January 2000

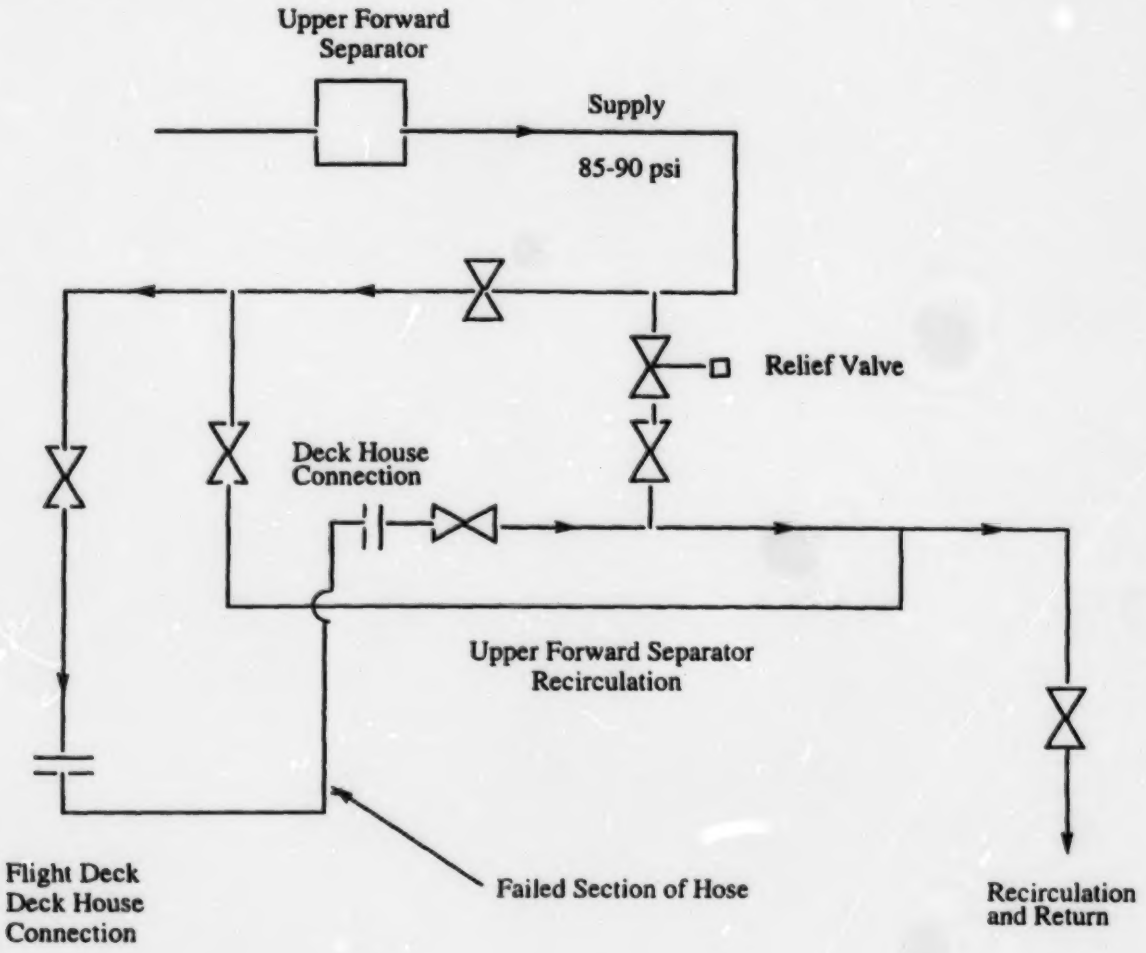
The failed section of hose is shown in Figure 2. The failure penetrated the hose, that is both the inner tube and cover were split over a distance of approximately 6 inches and the reinforcing fibres were broken. One end of the failure surface approached to within approximately 2 inches of the coupling. Figure 3 shows an expanded view of the failure surface on the exterior of the hose.

Figure 1 - Diagram of the flight deck aviation fuel delivery system HMCS Preserver.

Figure 2 – Photograph of the failure in the refuelling hose from HMCS Preserver Note the proximity of the failure to hose coupling.

Figure 3 – Close up view of failure shown in Figure 2

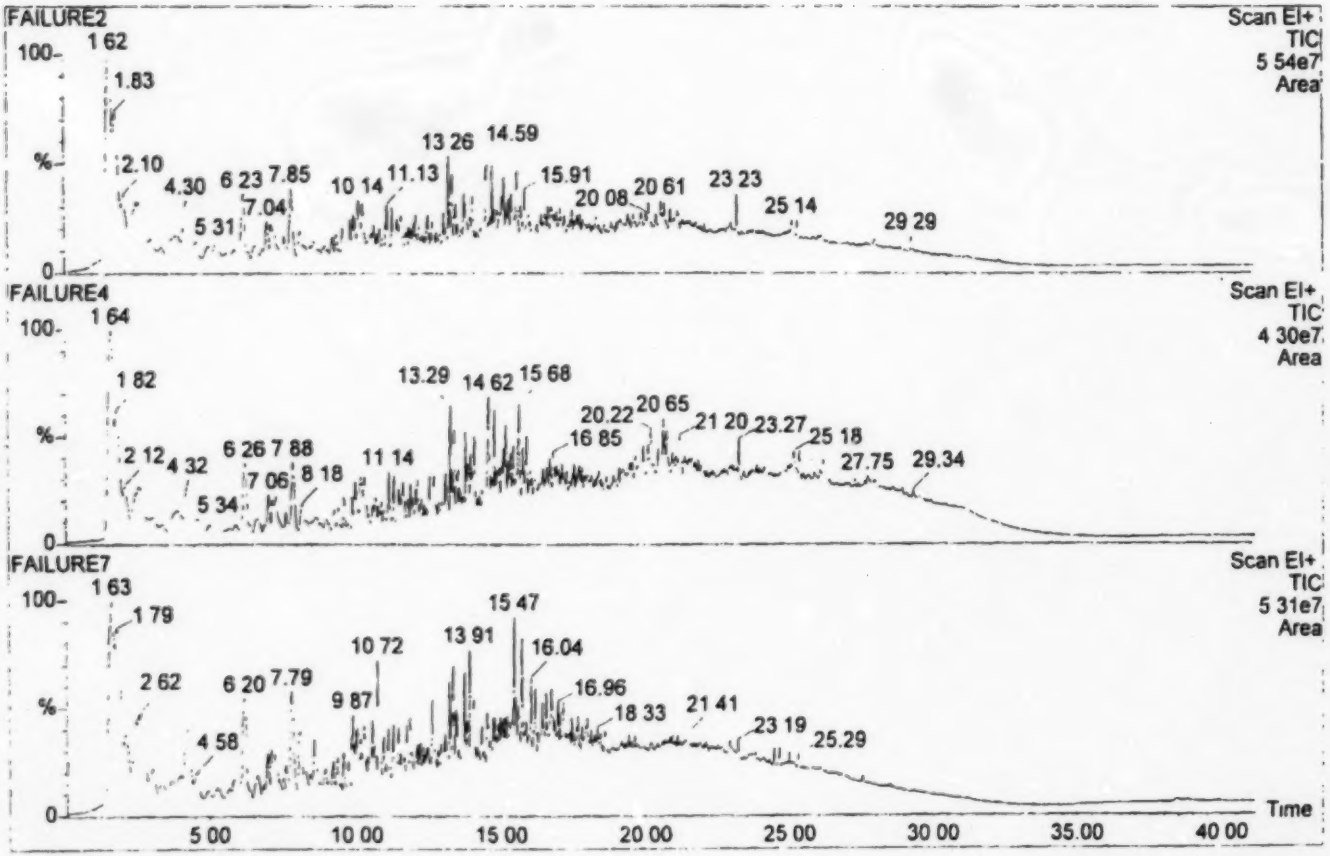
Pyrograms of the outer rubber cover, the exterior of the outer rubber cover, and the inner rubber tube are shown in Figure 5. Comparison of the pyrograms indicates that the rubbers giving rise to these chromatograms are similar. Mass spectral analysis of the peaks indicates that the pyrolysis products include the dimer of butadiene, ethenylcyclohexene, at 6.23 minutes in Figure 5a, and several peaks characteristic of the pyrolytic degradation of poly(butadiene-acrylonitrile) rubber at 8.60 minutes, 10.10 minutes, 10.79 minutes, and 15.43 minutes. These compounds have molecular weights of 93, 103, 107 and 160 respectively.

The pyrograms of the outer rubber cover (Figures 5a and 5b) also contained 1-chloro-4-(1-chloroethenyl)cyclohexene (~14.80 minutes). 1-chloro-4-(1-chloroethenyl)cyclohexene is the dimer of the monomeric unit of poly(chloroprene) rubber and is the major pyrolytic degradation product of poly(chloroprene) rubber. No evidence of poly(chloroprene) rubber was found in the sample from the inner tube.

Figure 5 – Pyrograms of a) outer rubber cover, b) the exterior of the outer rubber cover, and c) the inner rubber tube of the failed Titan MIL-H-6615E refueling hose.

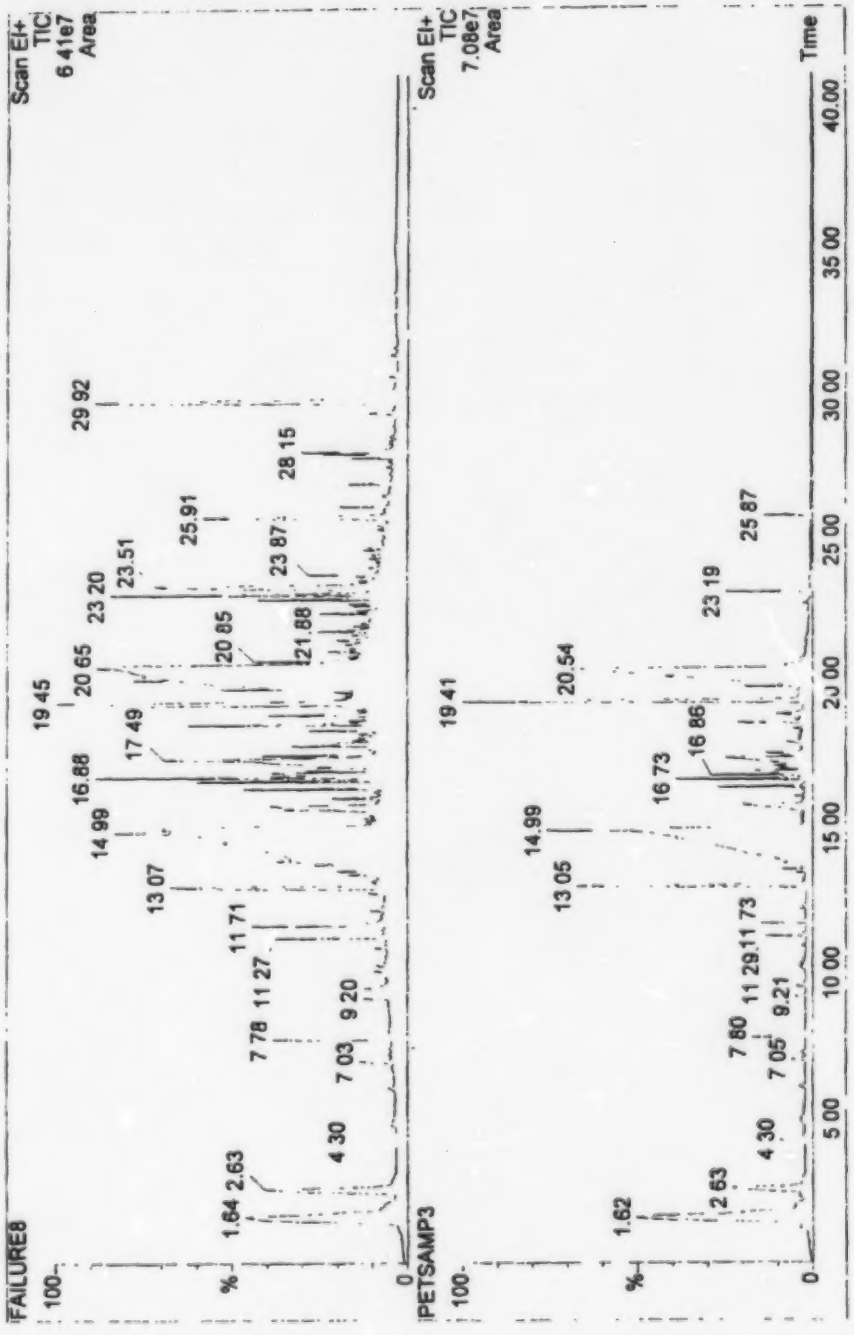
The pyrogram of the reinforcing material is shown in Figure 6a. Analysis of the pyrolysis degradation products indicated that the fibres were composed of poly(ethylene terephthalate) or PET. A pyrogram of a standard sample of PET is shown in Figure 6b.

Figure 6 - Pyrograms of a) reinforcing fibre from failed Titan MIL-H-6615E refueling hose and b) standard sample of poly(ethylene terephthalate).

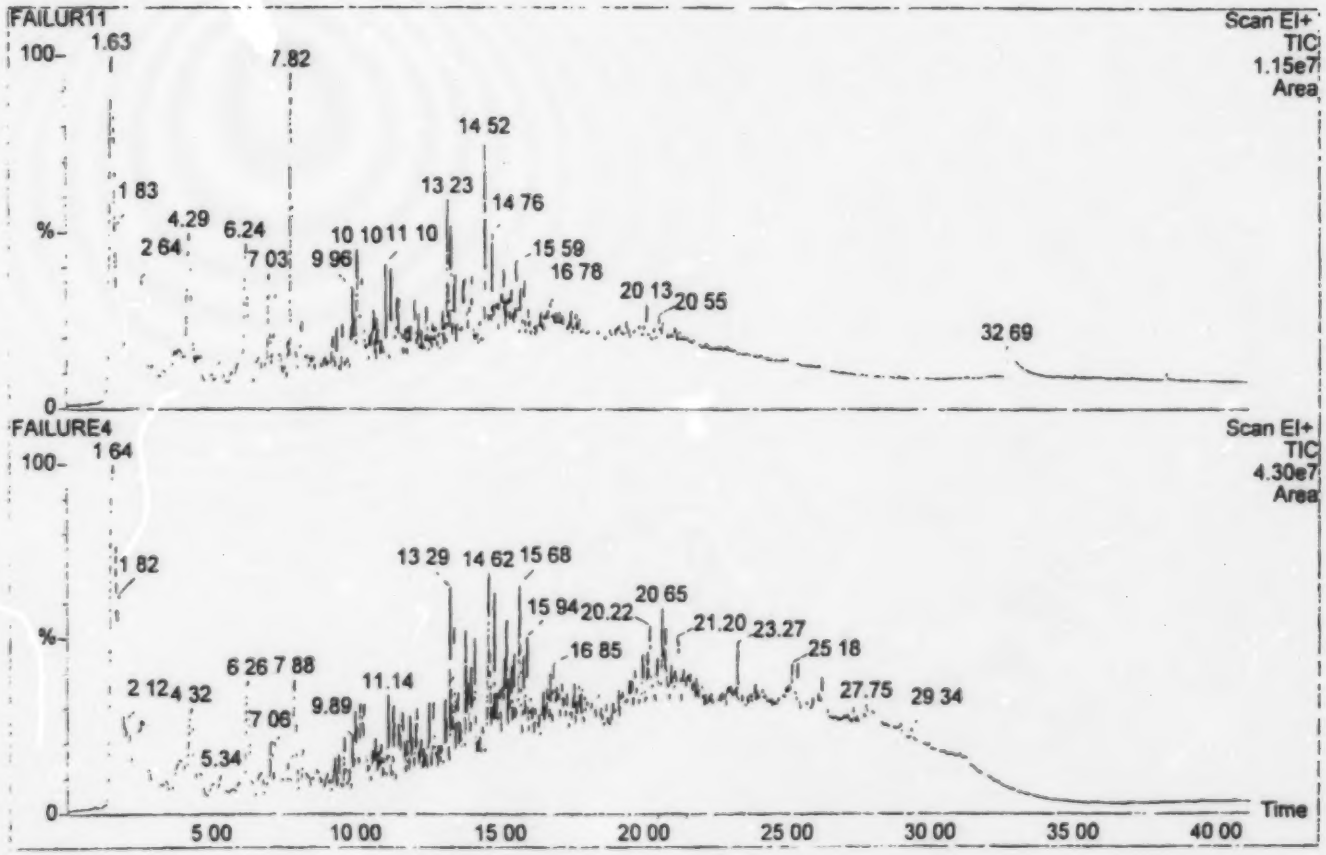
Figure 7 – Pyrograms of the outer rubber cover from a) an unused length and b) the failed length of Titan MIL-H-6615E batch SPO770-98-MYN62 refueling hose.

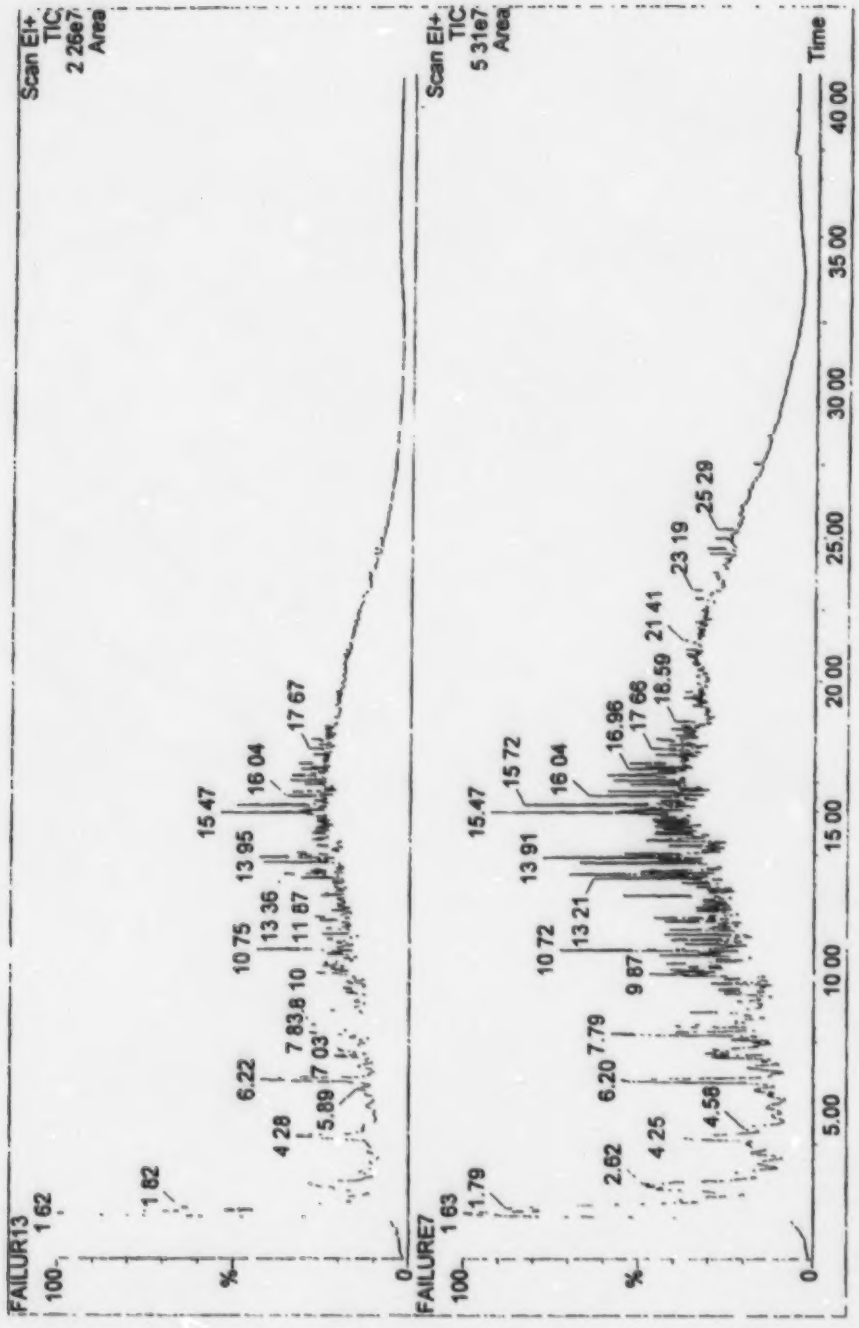
Figure 8 - Pyrograms of the inner rubber tube from a) an unused length and b) the failed length of Titan MIL-H-6615E batch SPO770-98-MYN62 refueling hose.

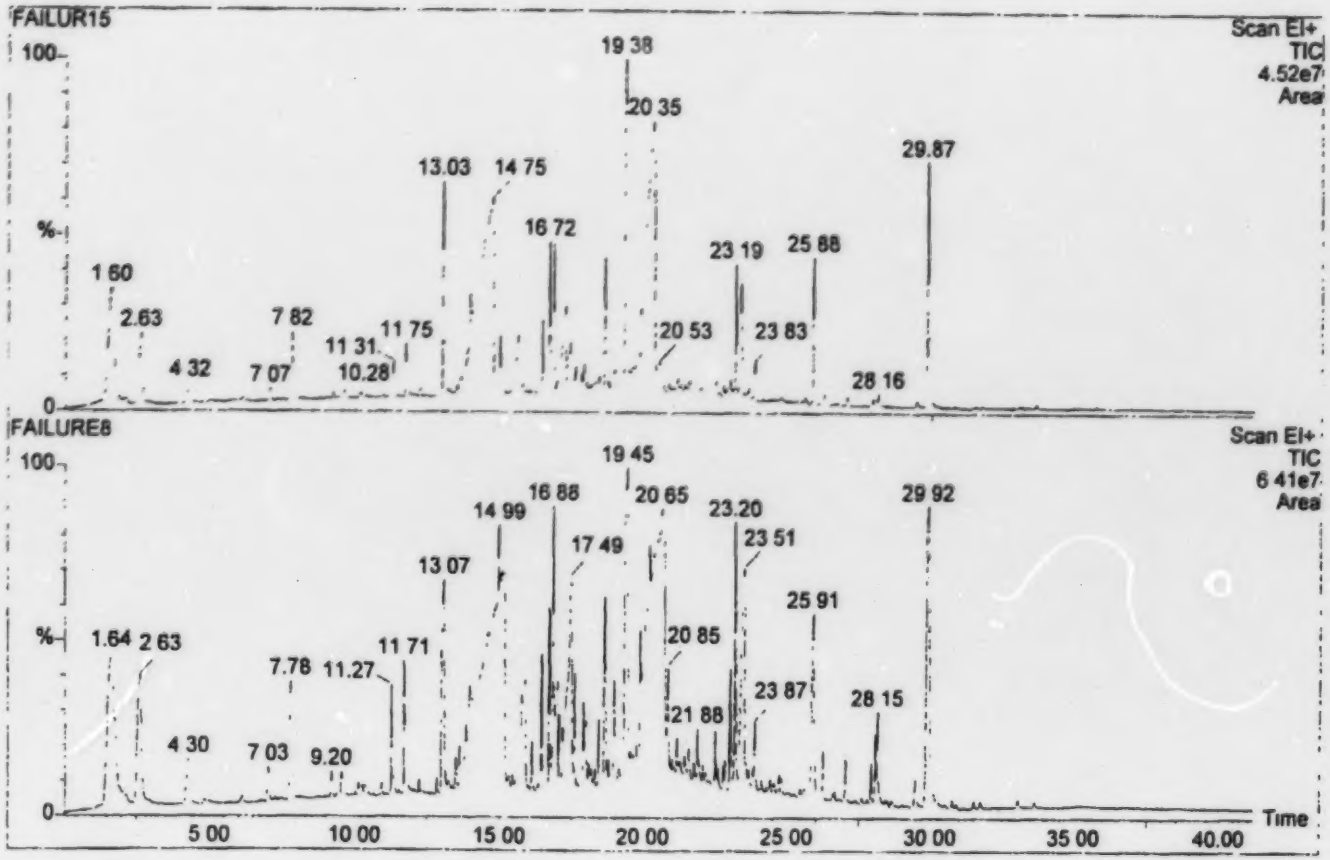
Figure 9 - Pyrograms of the reinforcing fibre from a) an unused length and b) the failed length of Titan MIL-H-6615E batch SPO770-98-MYN62 refueling hose.

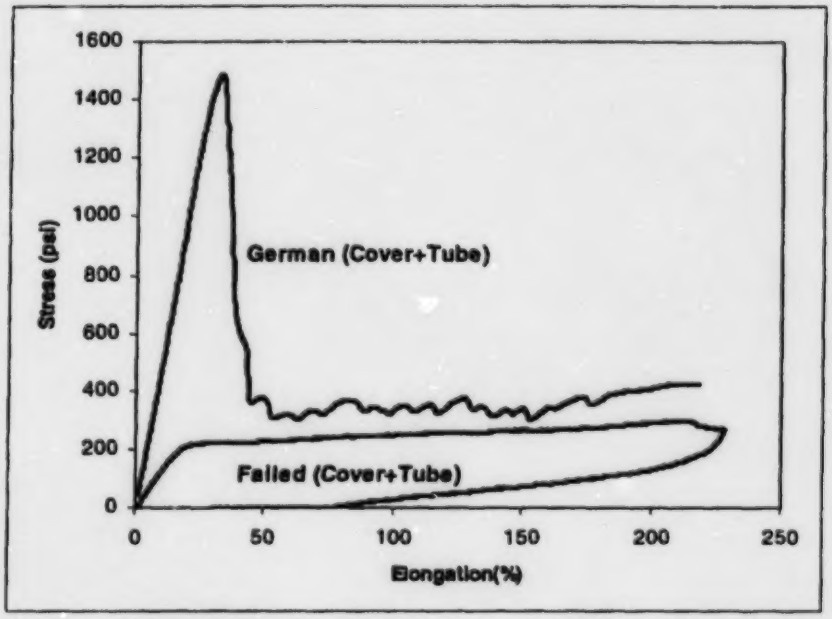
The plots of stress versus elongation for the intact tensile specimens from the Titan and German refueling hoses are shown in Figure 14. It is apparent from the plots that the Titan and German hoses are different. The Titan fuel hose did not break during the test and both loading and unloading curves are found in the figure. The maximum stress at 230% elongation was approximately 300 psi. As the Titan tensile specimen did not rupture during the test, 230% elongation is not the limit for the Titan tensile test specimens. The maximum elongation (230%) of the specimens was limited by the stroke of the Instron Model 8801 testing machine (6 inch maximum) and the initial sample gauge length of 2.3 inches.

In contrast to this the German hose began to fail at 40% elongation and supported a maximum stress of 1500 psi at that elongation. The failure of the German hose could be followed during the tensile test. The failure initiated with the rupture of the reinforcing fibres when the stress reached 1500 psi. As the fibers ruptured and separated, the load supported by the specimen dropped rapidly. The outer cover could not sustain the load and began to rip slowly. The load supported by the specimen continued to drop and was transferred to the inner tube. Initially the inner tube was loaded over a short portion

Figure 14. Plots of stress versus elongation of the intact tensile specimens from the Titan and German refueling hoses.

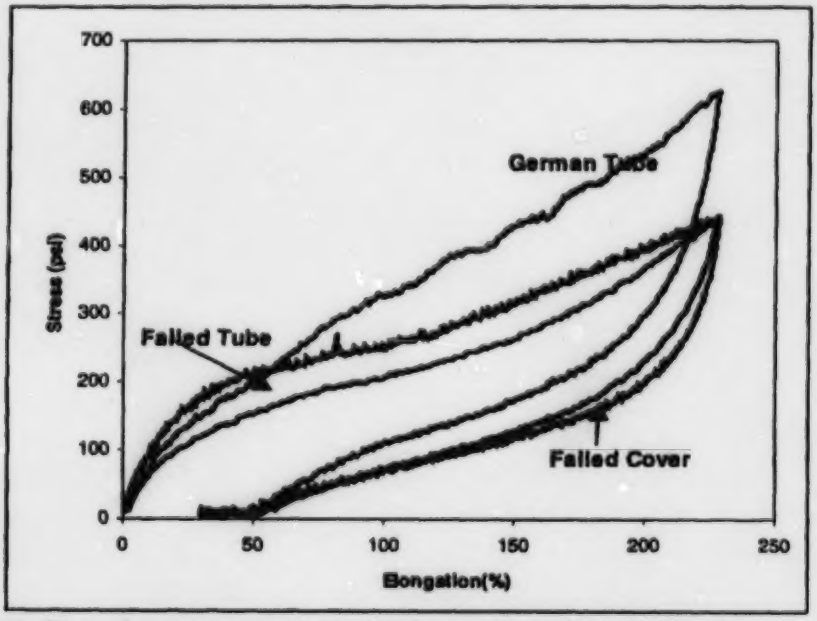
Plots of stress versus elongation for tensile specimens taken from the outer cover and inner tube of the Titan hose, and the inner tube of the German hose are shown in Figure 15. The slopes of the stress versus strain plots indicate that the inner tube from the German hose has a slightly larger modulus of elasticity than the inner tube of the failed hose. The German inner tube reached a stress of 630 psi at 230% elongation while the inner tube and outer cover of the failed hose reached stresses of 440 psi at 230% elongation.

Figure 15. Plots of stress versus elongation for tensile specimens from the outer cover and inner tube of the Titan hose, and the inner tube of the German hose.

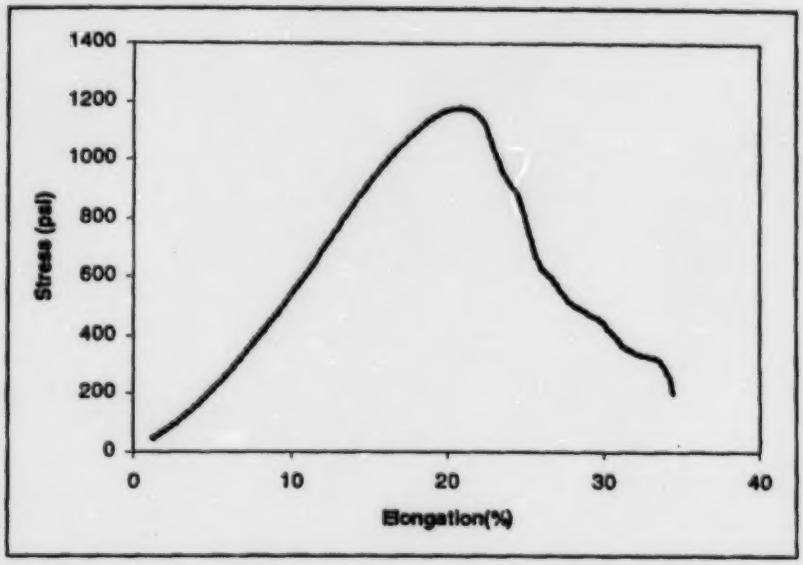
The tensile test result for the outer cover of the German hose is shown in Figure 16. This was plotted separately because it was not possible to separate the outer layer of reinforcing fibres from the outer cover. It can be seen in Figure 16 that the reinforcing fibres had a significant effect on the performance of the sample, i.e., the maximum stress increased to 1200 psi and the sample failed at 34% elongation.

Figure 16. Plot of stress versus elongation for tensile specimen from the outer cover of the German hose. This sample had the outer layer of reinforcing material attached.

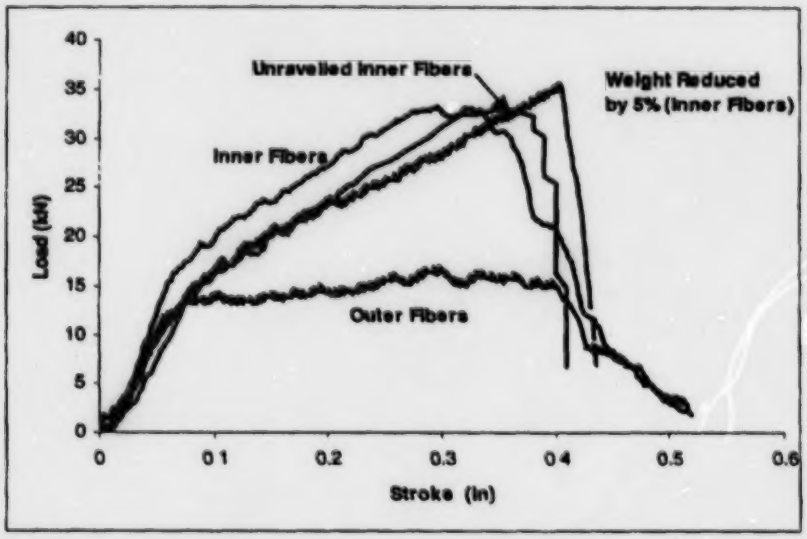
As neither unraveling nor reducing the weight of the inner fibre by 5% resulted in a load/stroke response similar to the outer fibre from the failed hose, this suggests one of three things. These are; the inner and outer fibres were different, the outer fibres were altered during manufacture of the hose, or the outer fibres were damaged during removal from the hose.

The mechanical properties of the inner and outer reinforcing fibres of the Titan were different. The peak load sustained by the outer reinforcing fibres was less than one half that sustained by the inner reinforcing fibres. This could be due to damage resulting from removing the fibres from the rest of the hose.

Figure 17. Plots of load versus stroke for fibres from the inner and outer layers of reinforcement from the Titan hose, an unraveled fibre from the inner layer, and a weight reduced inner layer fibre.

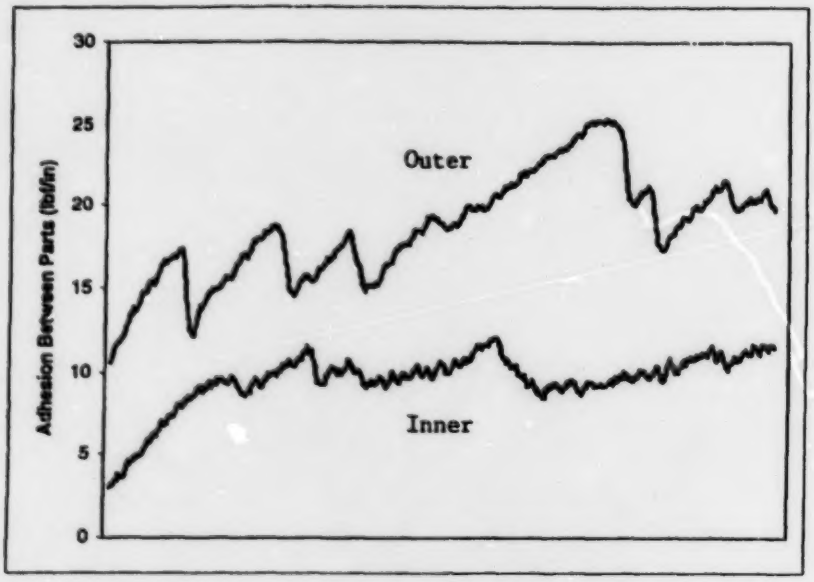
adhesion of the rubber to the outer fibres may have resulted in damage to the outer fibres when the fibre tensile test specimens were prepared.

The reinforcing fibres were not uniformly wound around the hose and the adhesion of the inner layer of reinforcing fibres to the rubber portion of the hose was significantly less than the adhesion of outer layer of reinforcing fibres to the rubber portion of the hose. Testing indicates that the adhesion for the inner layer of reinforcing was less than specified in MIL-H-6615E. The mechanical responses of the inner and outer layers of reinforcing fibres were also different. These factors may have been responsible for the failure of the hose.

Figure 18 - Plots of the load per lineal inch to separate the inner and outer reinforcing fibres from the remainder of the Titan hose.
